Experimental Study ND 98-01

**Evaluation of Portland Cement Concrete
as a Rehabilitation Option for
Overlaying an Existing Asphalt Roadway**

Second Evaluation Report

Project NH-2-052(012)244

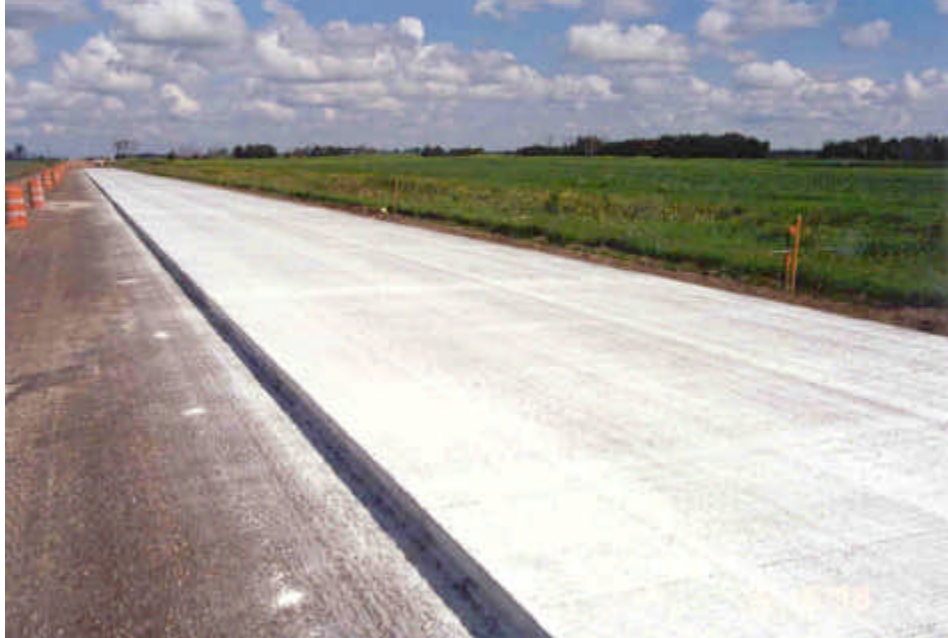
Photo 3 depicts an overview of the finished slab in the northbound lane of section 1 (5" PCC). The contractor commented that during the construction of the 5" PCC slab he had to lower the tie bars. This was necessary since the paver was hitting the top ends of the bars leaving them sticking out of the slab after the paver passed over them.

Photo 3 - Overview of finished slab in the northbound lane of section 1 (5" PCC).

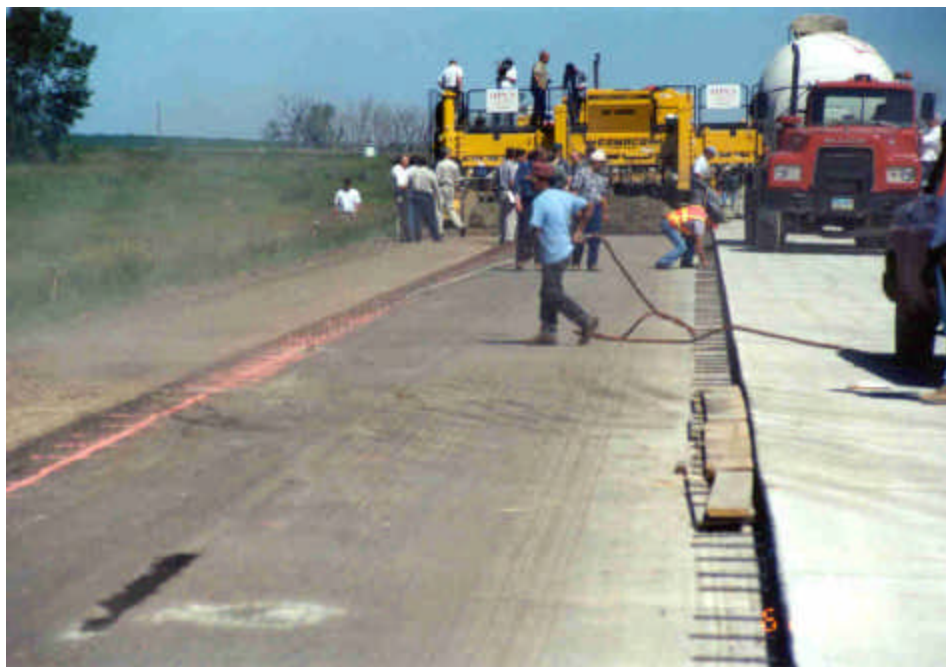
On June 25, 1998 the contractor began paving the southbound lane. A research team from the NDDOT again visited the site to monitor and evaluate the construction of the other half of the whitetopping test sections. Photo 5 is an overall view of the paving operation in the southbound lane.

Photo 5 - Paving operation in southbound lane.

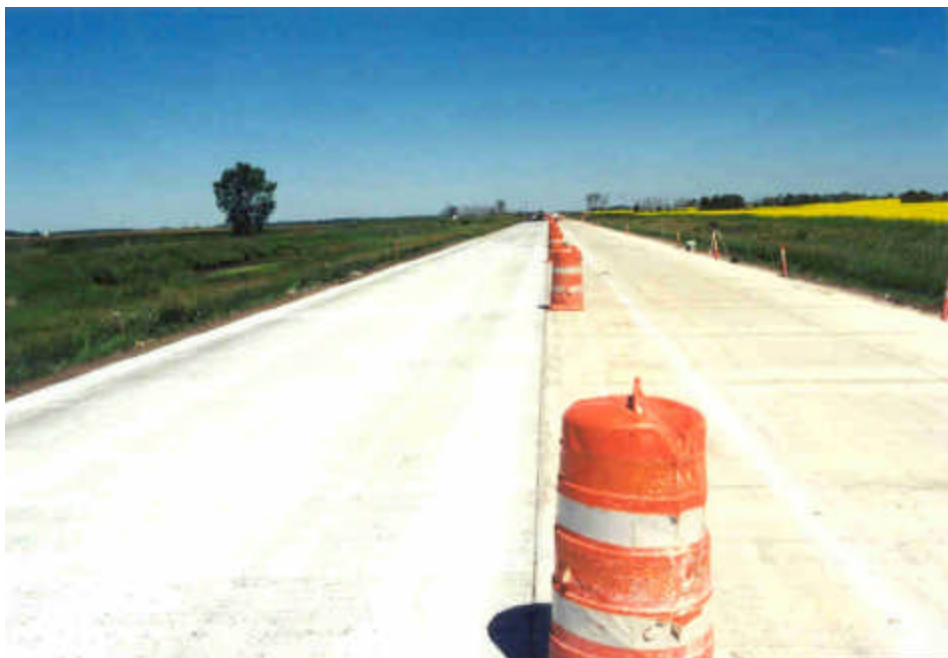
Photo 7 depicts an overall view of test section 1. A representative of the Materials and Research Division visited the site a few weeks after construction. The test sections were free of distresses except for a longitudinal crack located in the northbound lane near the beginning of test section 1. Photo 8 depicts a view of this distress which spans approximately 40'.

Photo 7 - Overall view of test section 1.

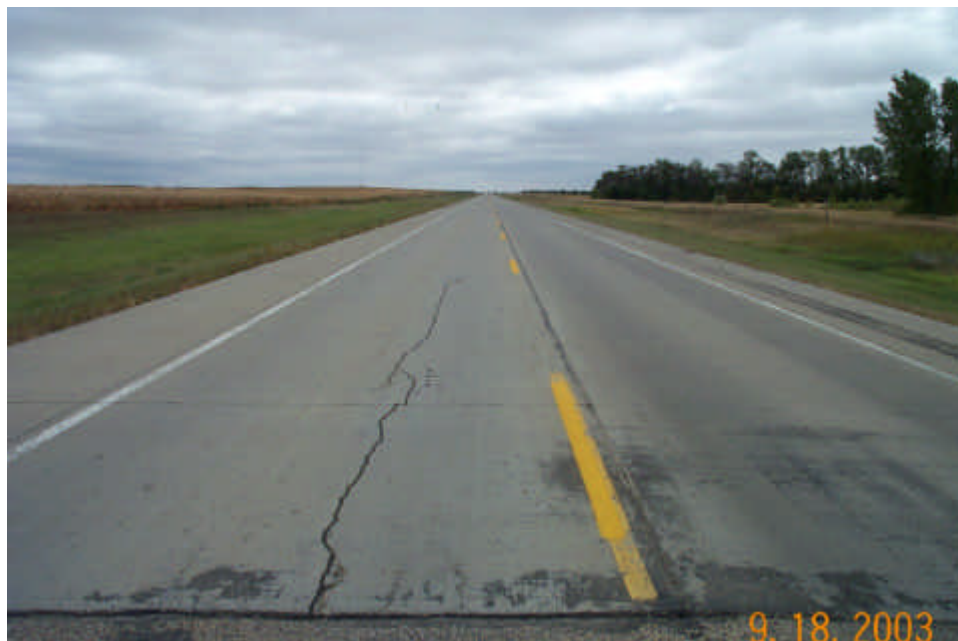
The first test section, which is composed of 5" PCC and 12" of HBP base, showed the most signs of distress along the joints of all three test sections. Photo 9 was taken in 2003. It shows a general overview of the first test section.

Photo 9 - Overview of test section 1 looking south.

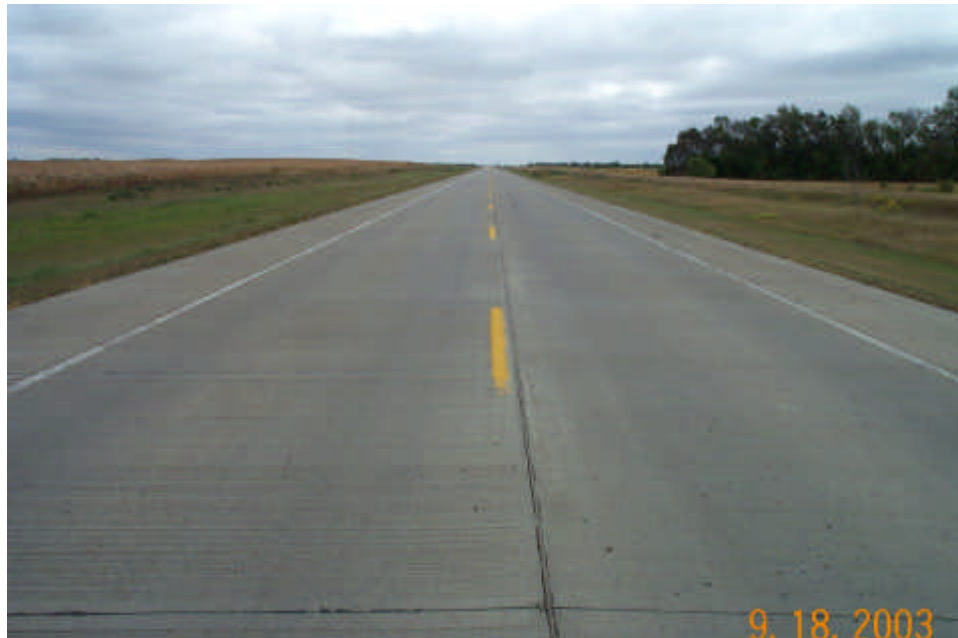
The second test section is composed of 6" PCC and 11" of HBP base and the overall pavement condition is performing very well.

Photo 14 - Overview of test section 2 looking south.

Section 2 has some low severity spalling occurring at transverse joints and also the centerline longitudinal joints. There is also approximately 12 feet of longitudinal cracking. Longitudinal and transverse joints along the shoulder are performing very well. The shoulders in this section show no signs of distress.

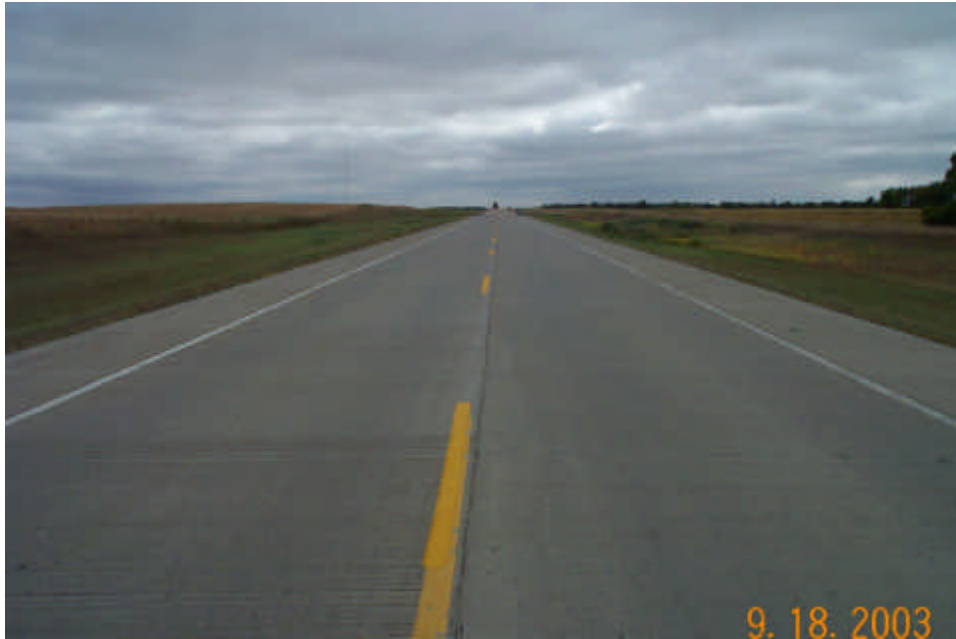
The third test section is composed of 7" PCC and 10" of HBP base and the overall pavement condition is performing satisfactory.

Photo 15 - Overview of test section 3 looking south.

The review team located approximately 104 feet of low severity longitudinal cracking that occurred in Section 3.
